GROUNDWATER QUALITY ANALYSIS REPORT

Prey Veng - Pea Reang - Kampong Prang (95F)

Tube Well Sample Locations and Health-Based Exceedances

Konpong Prang - Pea Reang - Prey Veang - Cambodia

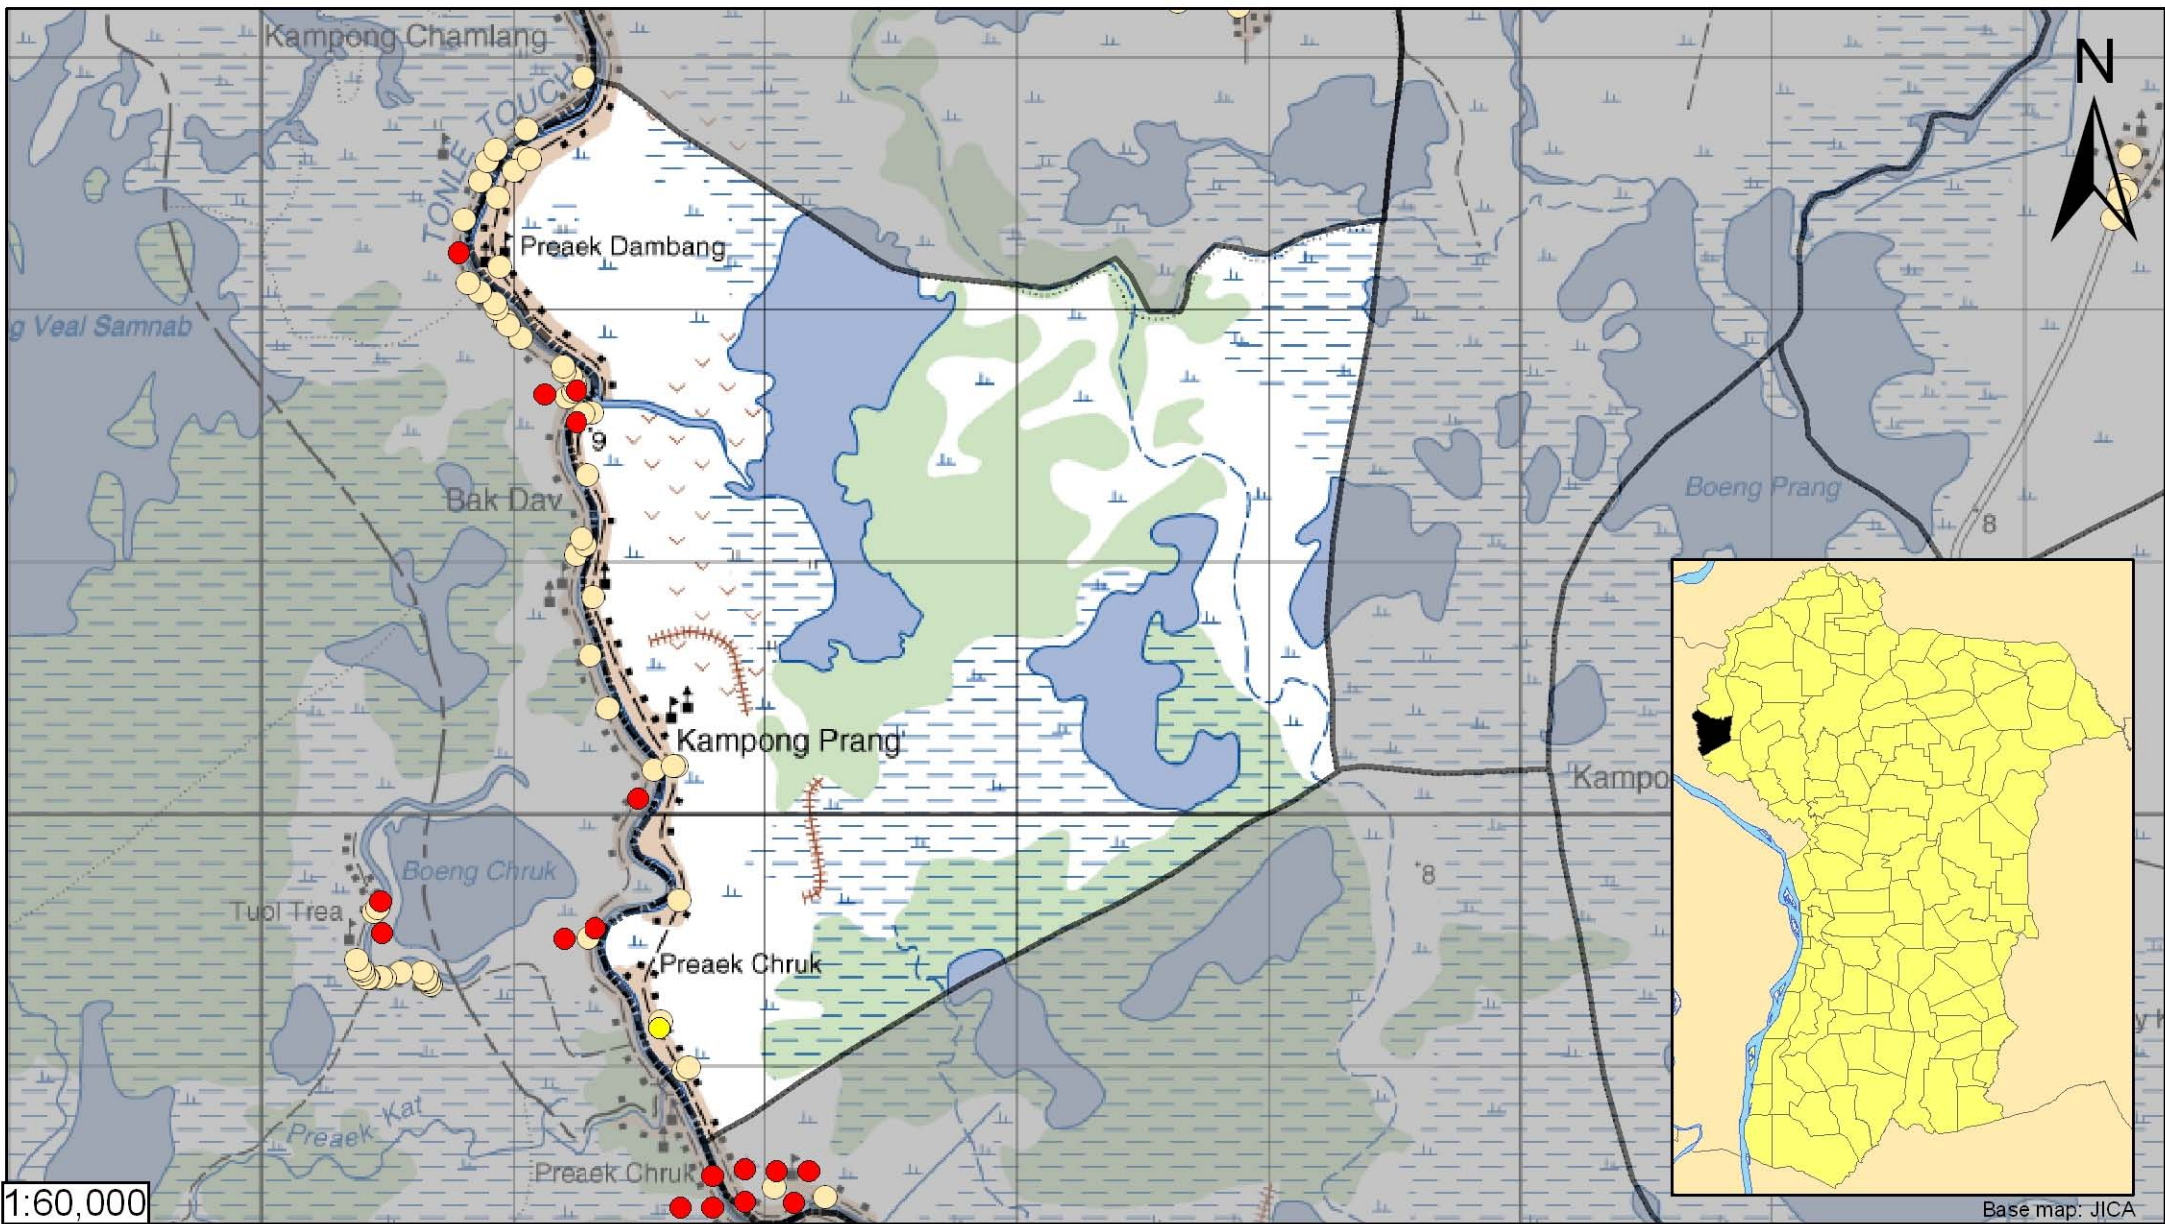
Kampong Prang is located in the district of Pea Reang. The population of this commune is approximately 6006 (2004). Groundwater sample collection occurred in December 2007 and consisted of the sampling of 16 tube wells throughout the commune. The attached figure presents the location of Kampong Prang within Prey Veng as well as groundwater sample locations and exceedances of health-impacting contaminants (when applicable).

Fluoride - Elevated concentrations of Fluoride were observed within the commune. The estimated probability of encountering unacceptable concentrations of Fluoride (>1.5 mg/L) in tube wells is 3%, based on the observed data. At concentrations greater than 1.5 mg/L, Fluoride can cause dental fluorosis and at concentrations greater than 4 mg/L, skeletal fluorosis can occur.

Provincial Boundary
- Locations exceeding the Cambodian water quality standards for major health-impacting contaminants have been colour-coded and arranged such that they do not overlap.
